009, LF009
2½"-3"

American Backflow
Products Company

Modification Overview

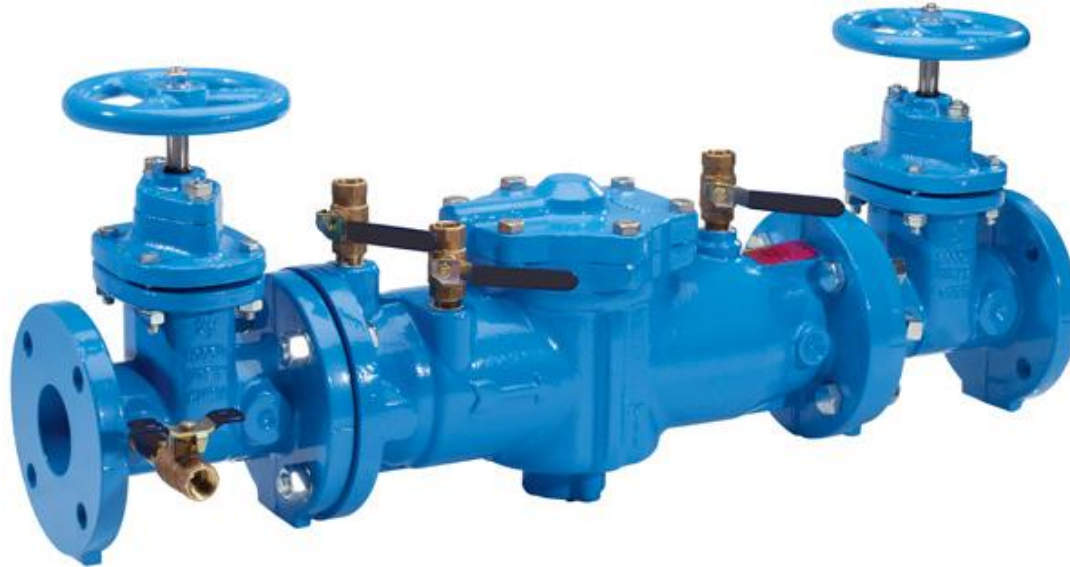
Production of the 009 began in 1989 and is current.

A lead free (LF) version was introduced in 2010. The leaded bronze parts were replaced with plastic or stainless steel.

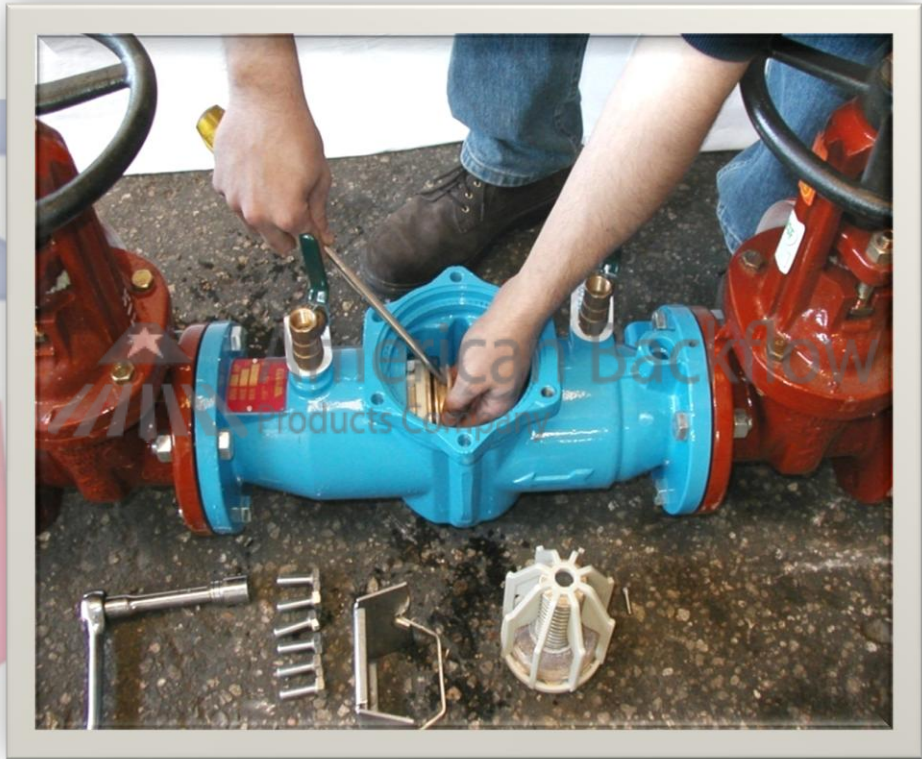
Check Seat Removal

Check seats are part of each module.

Check seats are attached to the cage with a bayonet type locking system.

- * Check spring is contained.
- * Hold the cage in one hand, push the seat inward and rotate counter-clockwise.

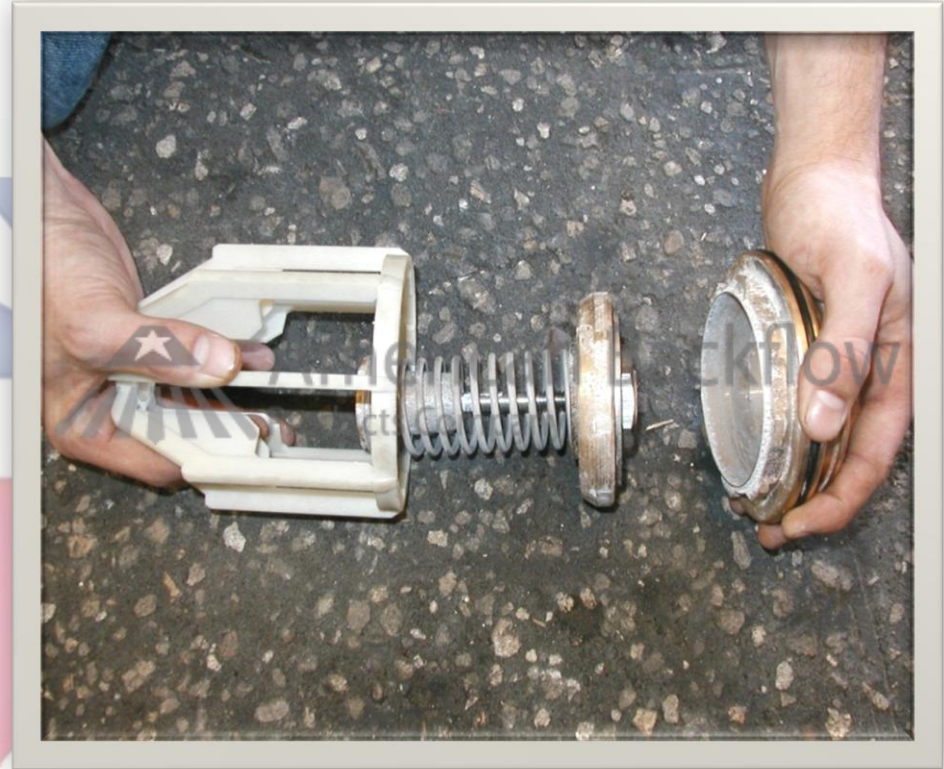
Check Disc Replacement

Remove retaining nut from disc holder and replace rubber.

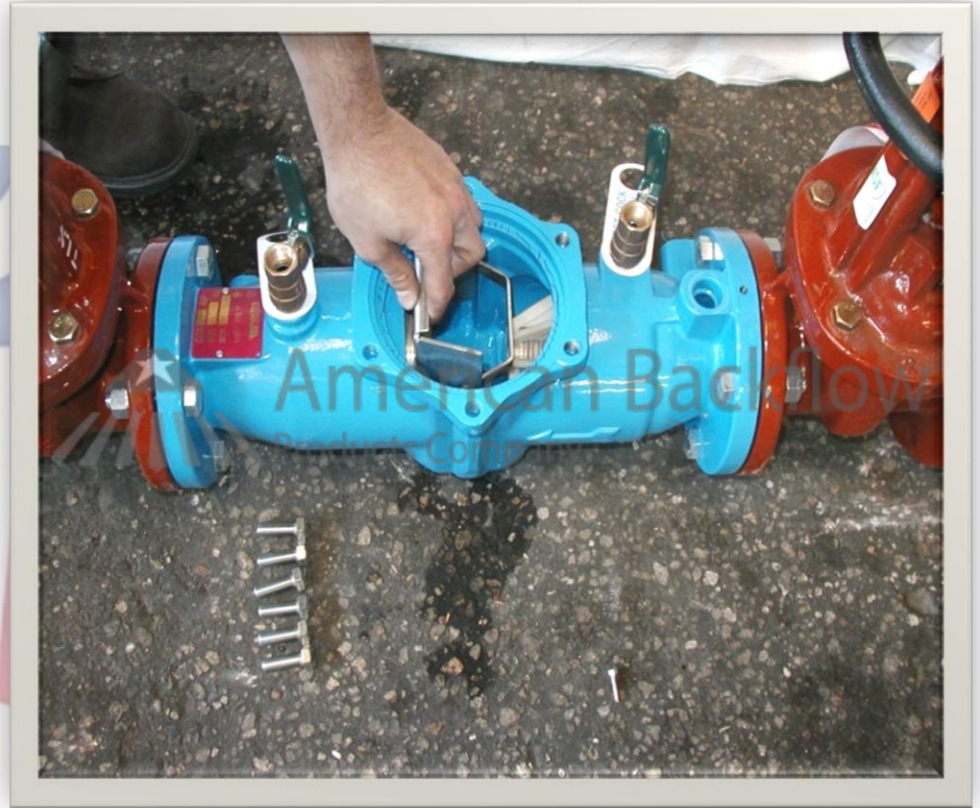
RV Stem Removal

The RV Stem and spring are situated between the check valves and are free once the single access cover is removed.

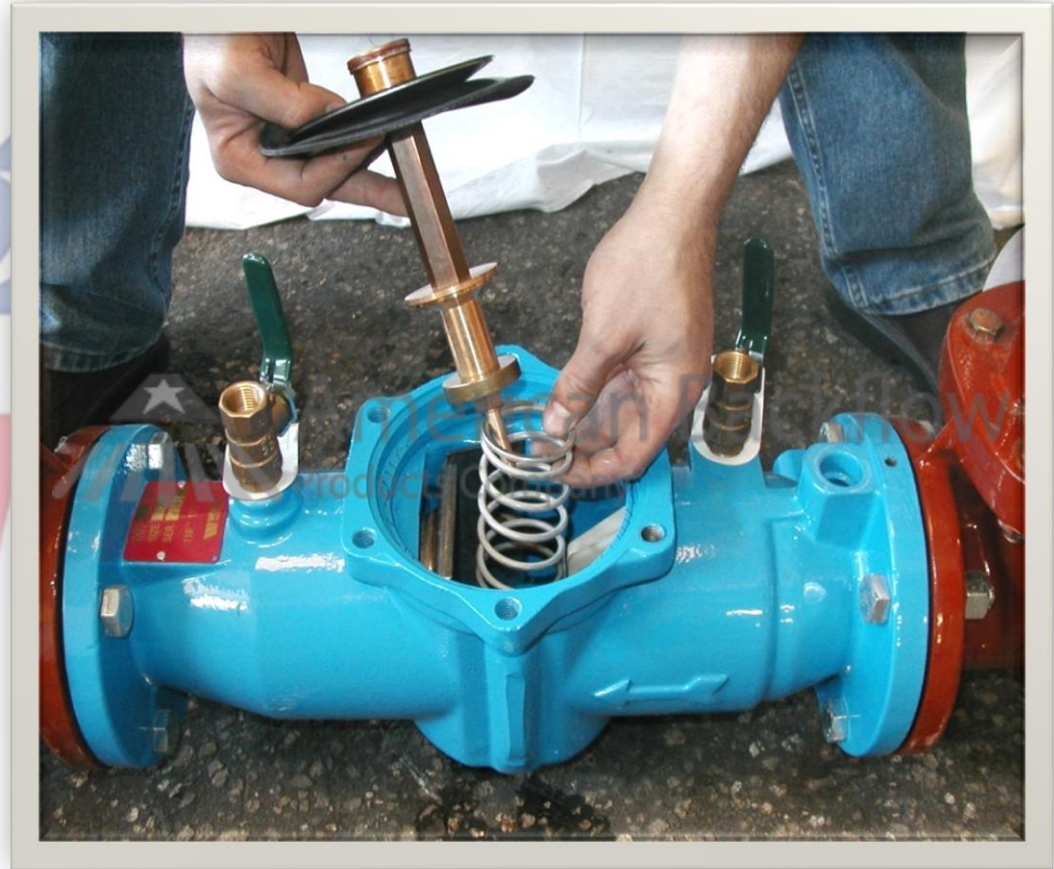
RV Seat Removal

Unless damaged, there is no need to remove RV seat.

The seat is pushed firmly into the body and is o-ring sealed.

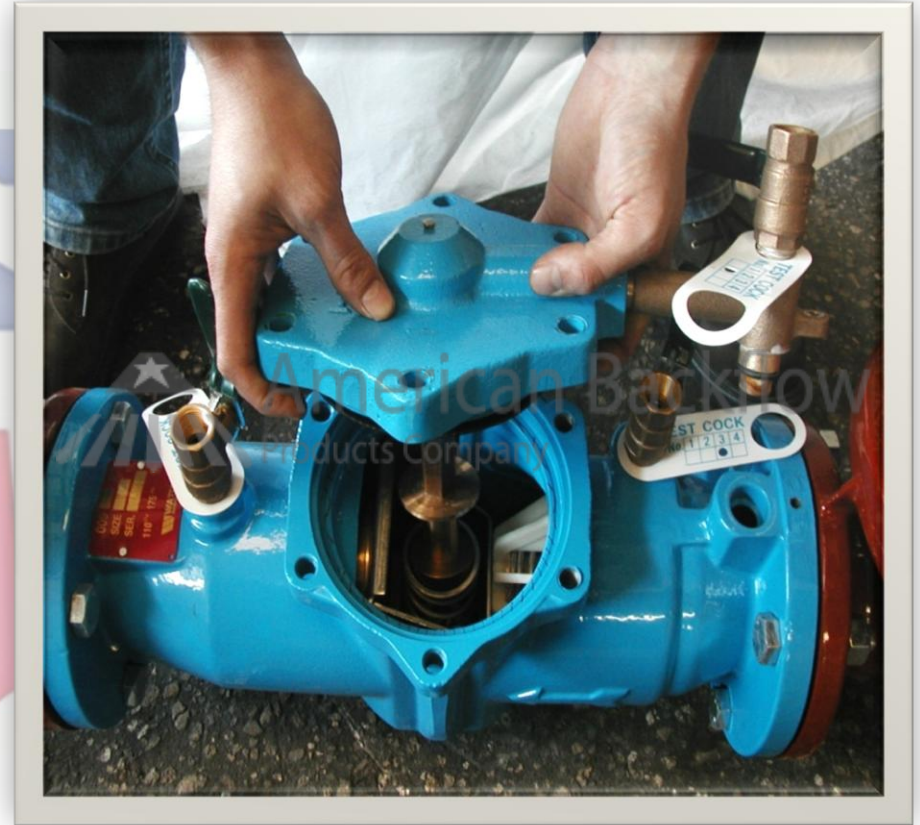
RV Reassembly Notes

Center the spring on the seat and insert the cover and stem assembly as a unit straight into the body.

Make sure that the lower guide on the RV stem goes through the guide hole in the seat.

If the cover will not press flat against body, the stem is crooked and must be realigned.
